EVALUATION OF TRANSPIRATION-COOLED TURBINE BLADES WITH

SHELLS OF "POROLOY" WIRE CLOTH

By Hadley T. Richards

MEMORANDUM 1-29-59E

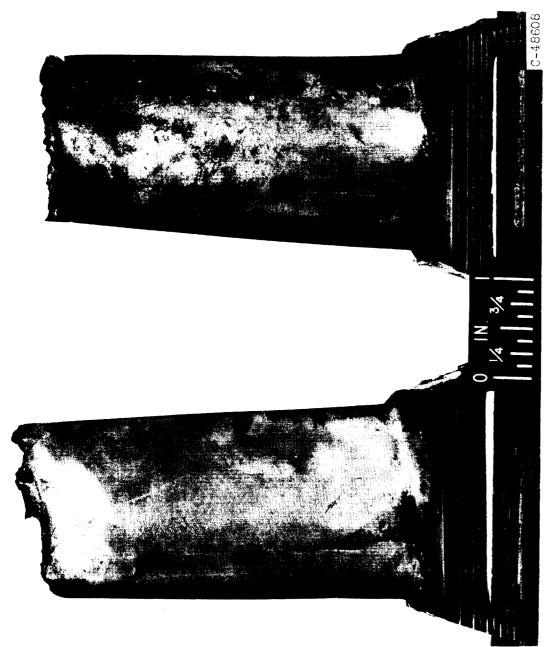
Blades 9 and 10. - After 10 minutes of preliminary operation at rated engine conditions, which was primarily to observe the shell temperature distribution by means of the temperature-sensitive paint, it was discovered that the tips of the shells of both blades had failed (fig. 2). The cause was probably the parting of the brazed junction at the blade tips with the resulting vibration of the unsupported surfaces leading to failure of the shell material.

- 2. The first two blades selected for endurance trials in an operating jet engine, failed at the tips after approximately 10 minutes of operation. These failures appeared to be due to the method of closing the airfoil tip by crimping and brazing the suction and pressure surfaces together.

Figure 2. - View of failure of tips of blades 9 and 10 after 10 minutes of engine operation.

In order to circumvent this difficulty on subsequent blades, the shell material was cut off even with the tip of the strut and a method of welding the tips closed by bridging from the tip of the strut outward to the wire shell was followed.

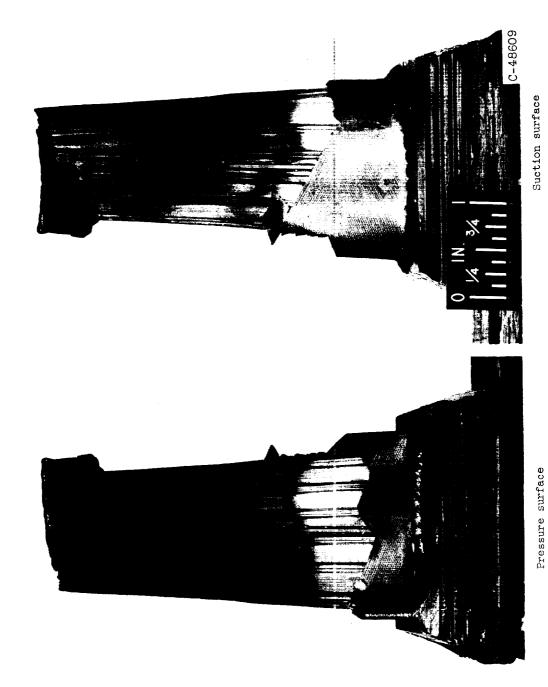
Blades 8 and 11. - Operation of blades 8 and 11 for their initial 10-minute period at rated engine conditions revealed that blade 8 had failed but blade 11 appeared to be undamaged. The failure of blade 8 is shown in figure 3. Most of the shell between the base and tip areas of the blade had broken away from the strut lands. Visual inspection of the lands in the areas where the blade shell no longer existed indicated there was little or no bond between the shell and the strut. Inspection of the shell that remained on the blade also revealed that there was poor bonding between the shell and the strut. The porous shell material at the root of the blades was apparently retained primarily by the weld at the blade platform. The shell at the tip was retained by the weld between the shell and strut at the extreme tip of the blade.

- 3. Operation of two more blades (8 and 11) with improved tip welding procedures gave widely differing results. One blade (8) lost most of the porous airfoil within the first 10 minutes of operation. Examination of the surface of the supporting strut indicated lack of satisfactory weld between the shell and the lands of the strut. The second blade (11) operated satisfactorily for 33 hours at rated engine conditions (including 10 engine starts), with a ratio of coolant-to-gas flow of 0.11.

Figure 3. - Failure of blade 8 after 10 minutes due to weld failure.

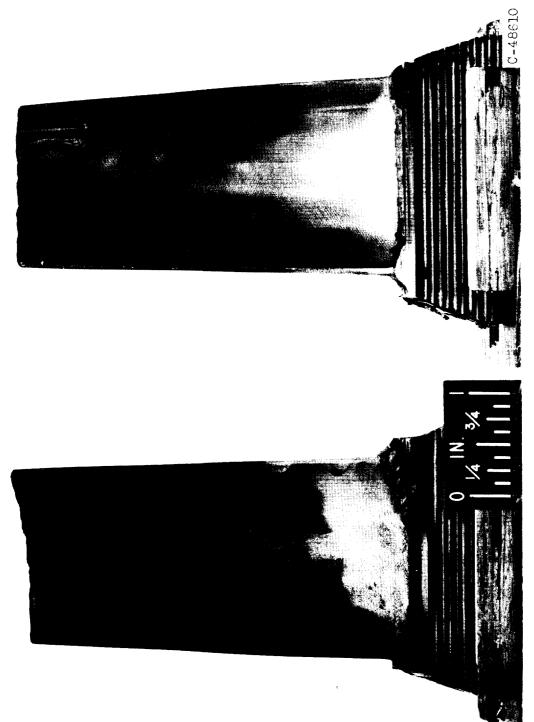
Inasmuch as the failure of blade 8 did not damage blade 11, operation of this latter blade was continued successfully for 33 hours, including 10 engine starts. The investigation was arbitrarily stopped at this time. The ratio of cooling-air flow to gas mass flow for blade 11 was maintained at approximately 0.11 for the endurance operation. If the permeability of the blade had been within the design limits, the ratio should have been 0.065. For a blade designed with the ideal permeability distribution, the required coolant flow would be only 0.02 for the conditions of this test. Figure 4 shows the condition of the blade at the conclusion of the tests.

The blackened areas are deposited carbon and a scorching effect that is caused by extended periods of operation on the temperature-indicating paint. The flow of cooling-air remained constant for a given pressure with blade operating time. This indicated that the carbon deposition and other foreign particles that might have been in the cooling-air or combustion gas did not affect the over-all permeability of the blade appreciably.

Figure 4. - Blade 11 after 33 hours of engine operation.

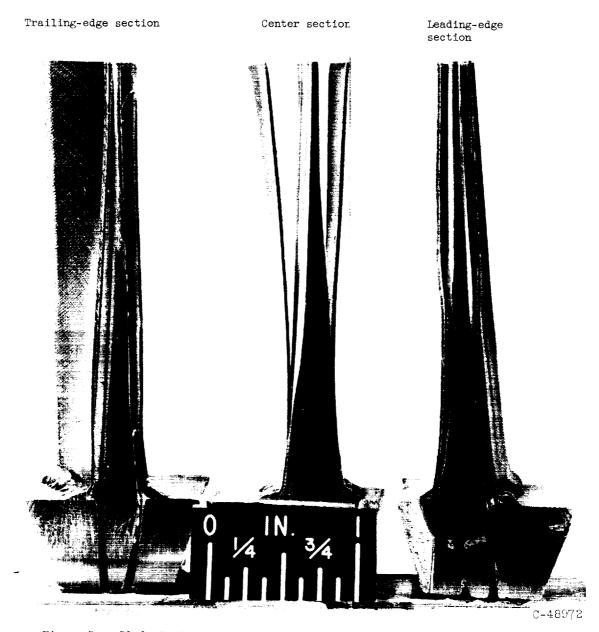
In view of the manner of failure of blade 8, it was decided that two blades that had not been operated previously should be cross sectioned to examine the bond between the airfoil shell and strut lands. Neither of these blades had well-bonded welds. A typical example was blade 4 shown in figures 5 and 6. The blade was sectioned in a spanwise direction as shown in figure 5. Figure 6 is an enlarged view of the center section in figure 5. Observation of the enlarged area shows no weld contact over the outer four-fifths of the span on either surface of the strut. The shell sections were separated by slight finger pressure to the position shown. The right-hand section in figure 5 is the blade leading-edge region. Again the shell was spread away from the supporting strut to indicate no contact from a point approximately 50 percent span outward. Although it is not clear from the figure, examination of the actual blade indicated only sporadic contact between any of the strut lands and the adjacent shell.

Two primary difficulties arise from lack of good bond between shell and strut: (1) the resultant lack of shell support and (2) less obvious, the defeat of the idea of compartmentalizing the cooling-air-supply volume. Because of the differences of pressure between adjacent compartments, flow between compartments would be altered from that intended, adversely affecting the cooling of the shell.

Figure 5. - Blade 4 after being sectioned at two chordwise locations showing the poor shell-to-strut bond.

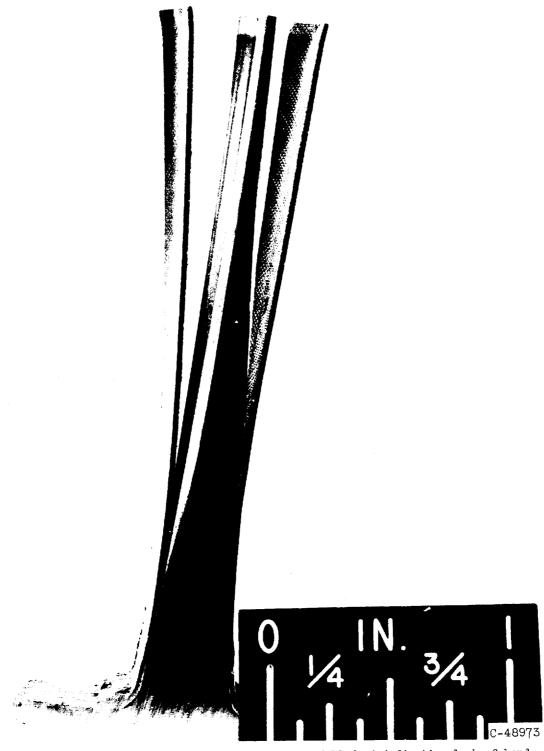
Figure 6. - Enlarged view of the center section of blade 4 indicating lack of bond between shell and strut
